Clearwater Valley Watershed Restoration Plan

December 2023

Clearwater Resource Council

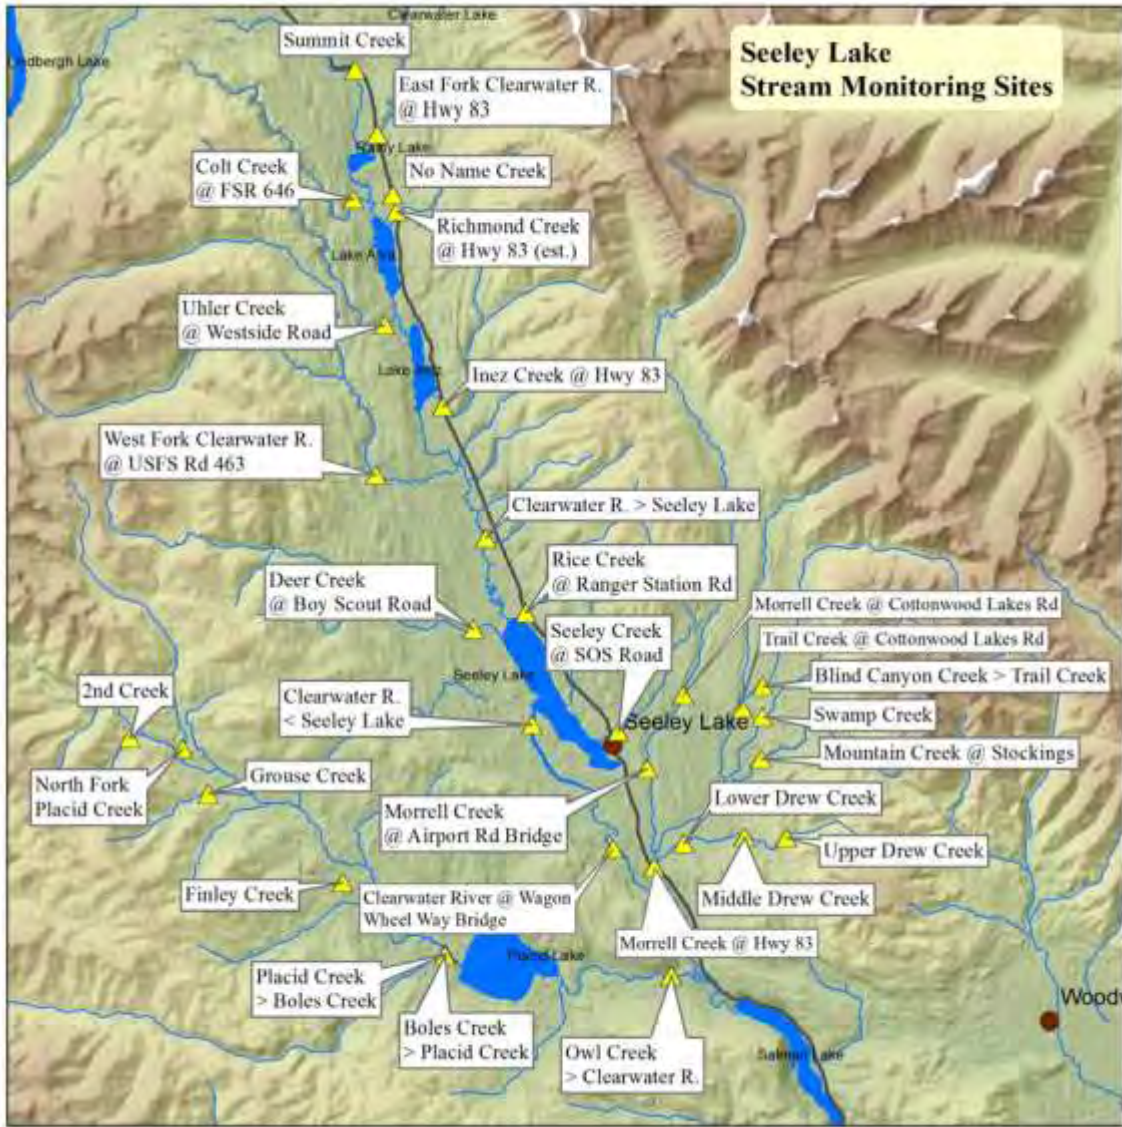
Figure 13. Locations of stream sampling sites conducted in the Clearwater Valley between 2013 and 2020.

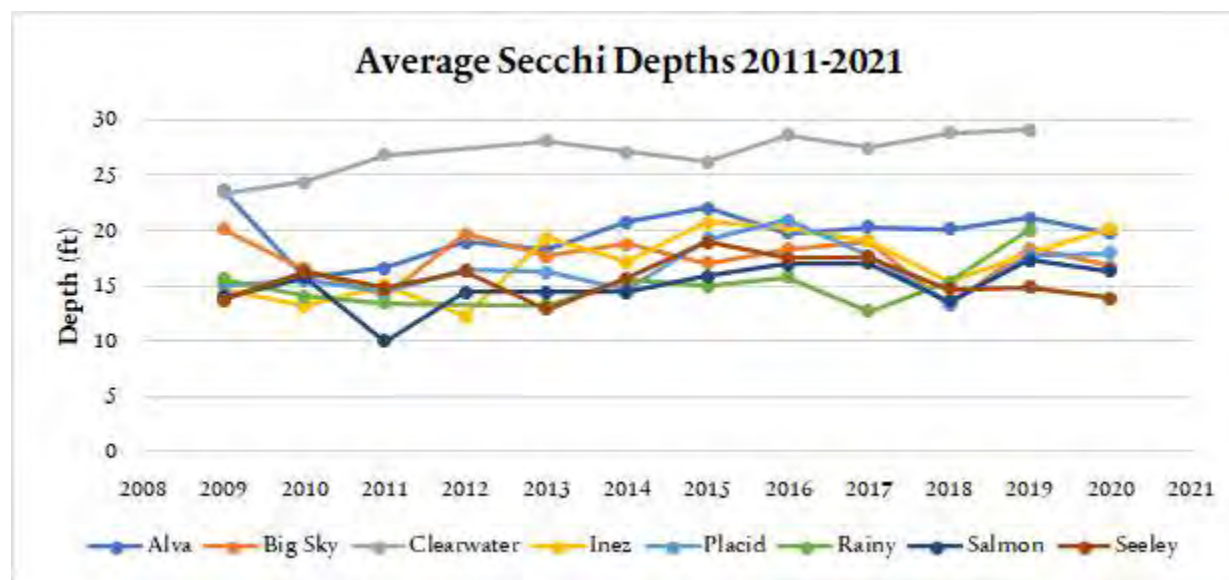
Figure 19. Yearly averages of Secchi depths recorded at one or more sites in eight lakes in the Clearwater Watershed, 2009 through 2020. Note that as of 2020, Clearwater and Rainy Lakes were omitted from monitoring.

There were no drastic changes or trends apparent in the Secchi data throughout 2009-2020. In general, there have been consistent differences between lakes and common patterns within lakes across years. For all lakes monitored through CRC's program, both Secchi depth and surface temperature typically increased as the summer progressed. There is year to year variability in each lake's mean transparencies and temperatures, but overall there have been no consistent declines or improvements in conditions throughout the entire period of monitoring (Figures 19 and 20). Lee et al. (1995) suggested criteria for trophic status of lakes (Table 7).

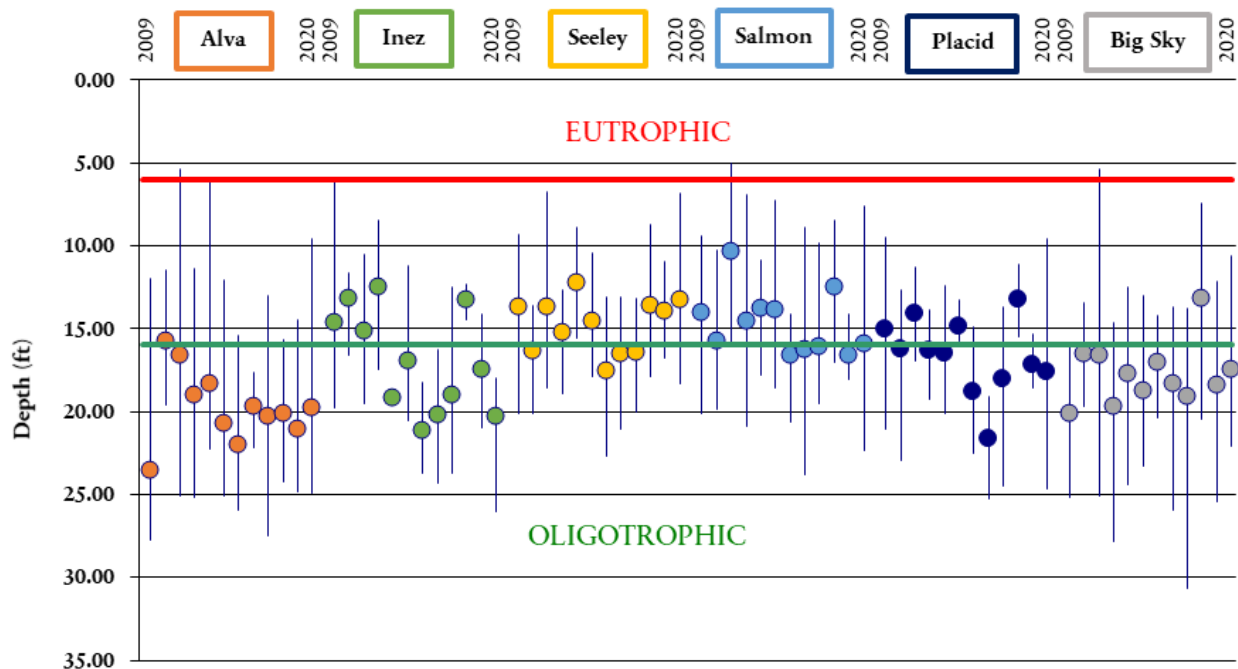
Figure 21. Continued mean (solid point) and range (vertical line) of Secchi transparencies recorded in six lakes in the Clearwater River Basin, 2009 through 2020. The red and green lines represent the bounds for transparencies considered indicative of eutrophic and oligotrophic conditions, respectively.

For the remaining lakes (Inez, Salmon, Placid, and Big Sky) the mean Secchi transparency in 2018 was one of the shallowest of all time. However, 2019 and 2020 showed deeper transparencies for all of these lakes, bringing each lake back to oligotrophic levels. One hypothesis is that the Rice Ridge Fire, which burned a large swath of land east of Seeley Lake, affected transparencies in 2018, which was 1-year post-fire. This hypothesis is

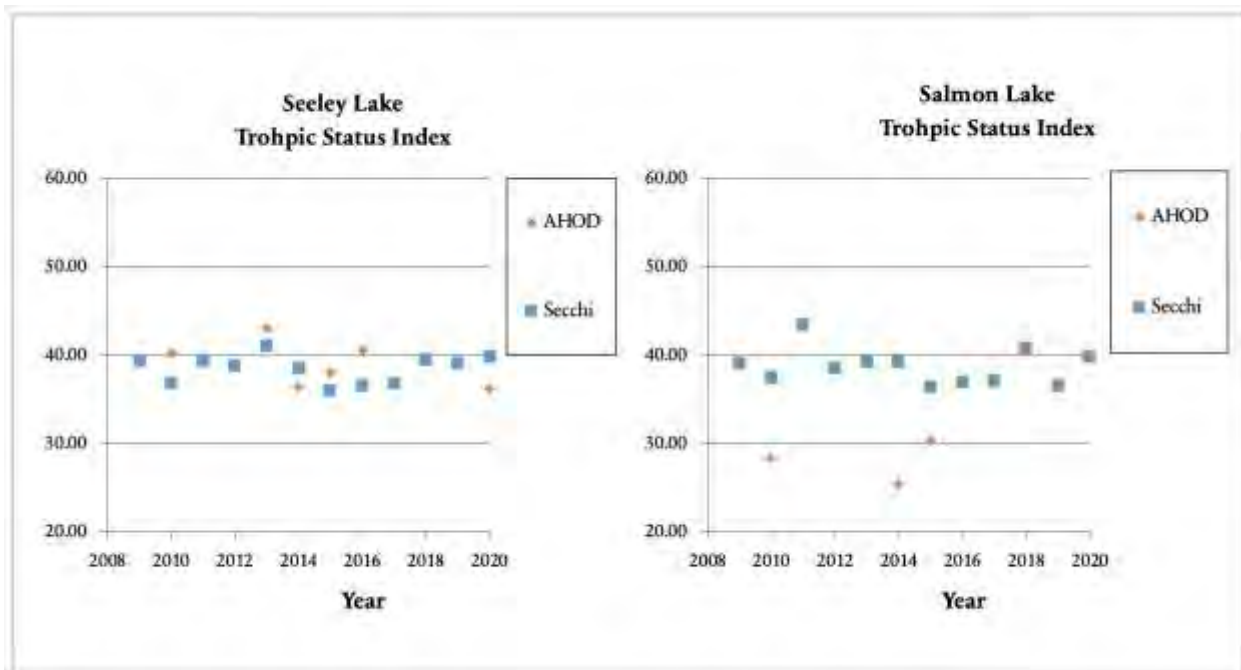
Figure 22: The trophic status index (TSI) calculated from areal hypolimnetic oxygen depletion (AHOD) and Secchi transparency for Salmon and Seeley Lakes from 2009 through 2020. Index values higher than 50 are considered eutrophic; those below 30 are considered oligotrophic. Methods for TSI, values for earlier years, and other metrics are available in Watson (2012).

Areal hypolimnetic oxygen depletion (AHOD) rates and transparency were used to estimate Trophic Status Indices (TSIs) on Seeley and Salmon lakes (when sufficient data were collected), which allow us to compare lake conditions over time (Figure 22). The TSIs calculated from transparency and AHOD for Seeley Lake were similar and indicate that Seeley Lake is mesotrophic with no apparent trend in the recent or historical data.

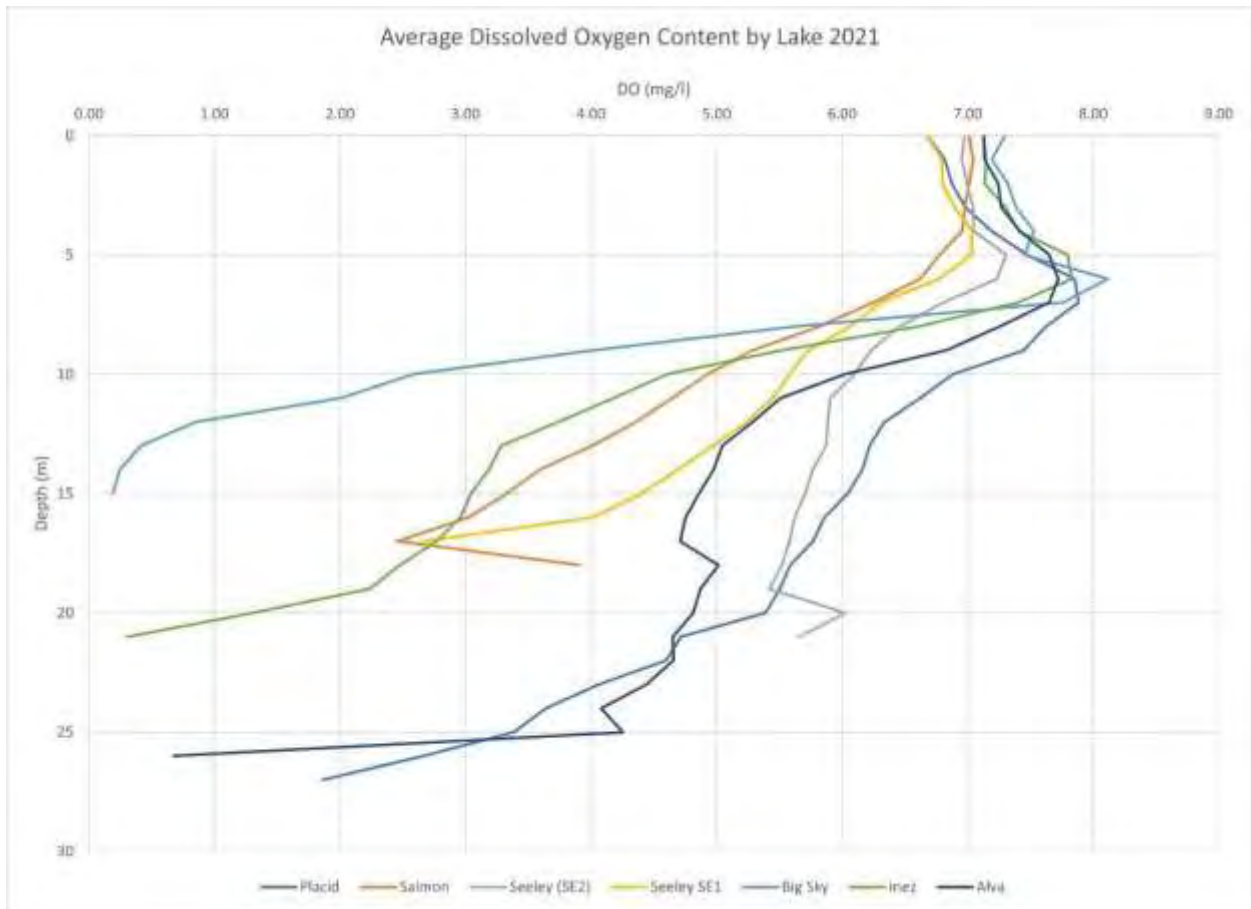
Figure 23. Dissolved oxygen by depth averaged across the 5 sampling times for each of the sampled lakes in 2021.

DO monitoring was conducted in all six of the lakes in 2021-2023. Comparisons of DO levels across the lakes are shown in Figures 23-25. These data support the same conclusions as found with the 2009-2020 sampling. However, the DO levels observed in Big Sky Lake are a concern, as this lake exhibited very low DO levels at depth throughout the entire sampling season. While Big Sky Lake's secchi disk readings were good, the DO levels are a significant concern.

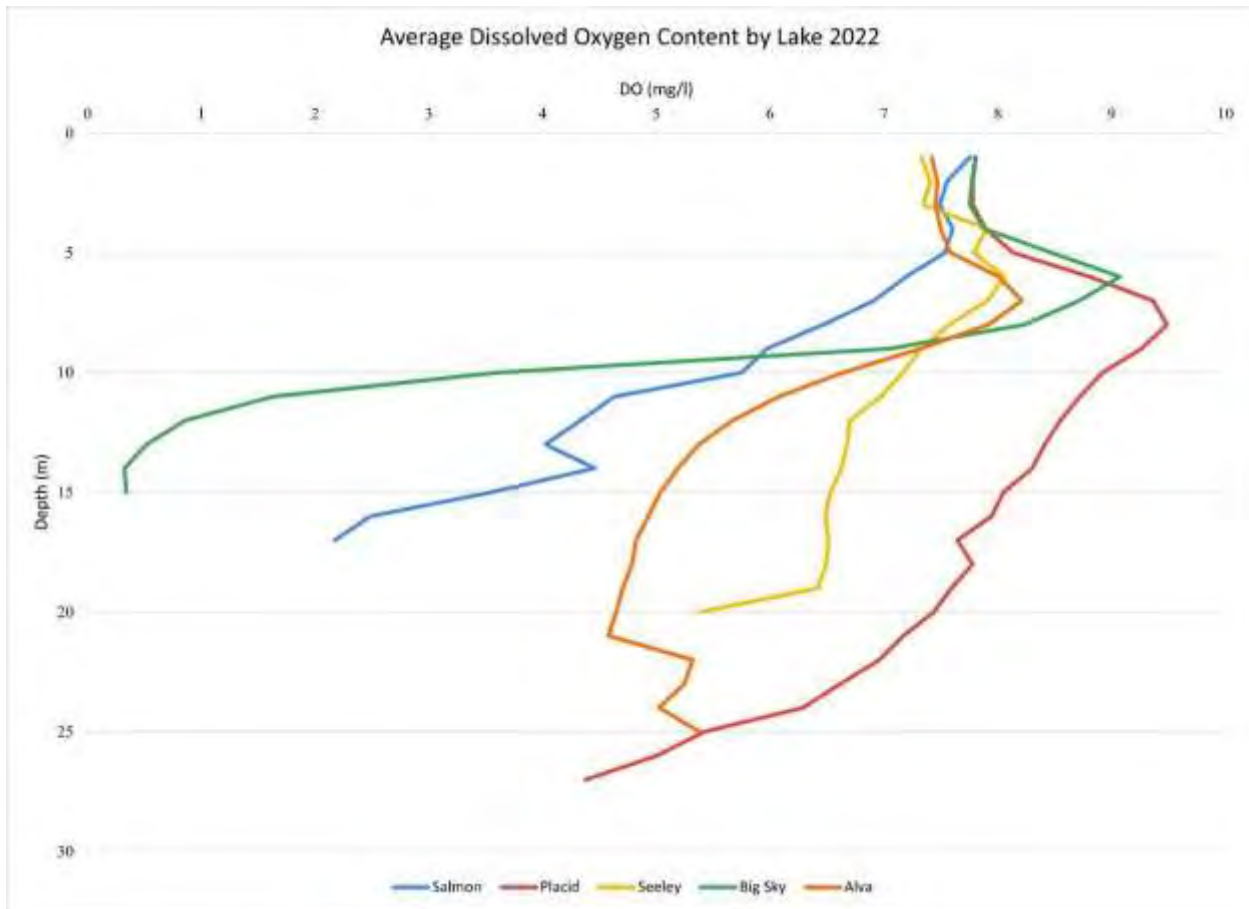
Figure 24. Dissolved oxygen by depth averaged across the 5 sampling times for each of the sampled lakes in 2022.

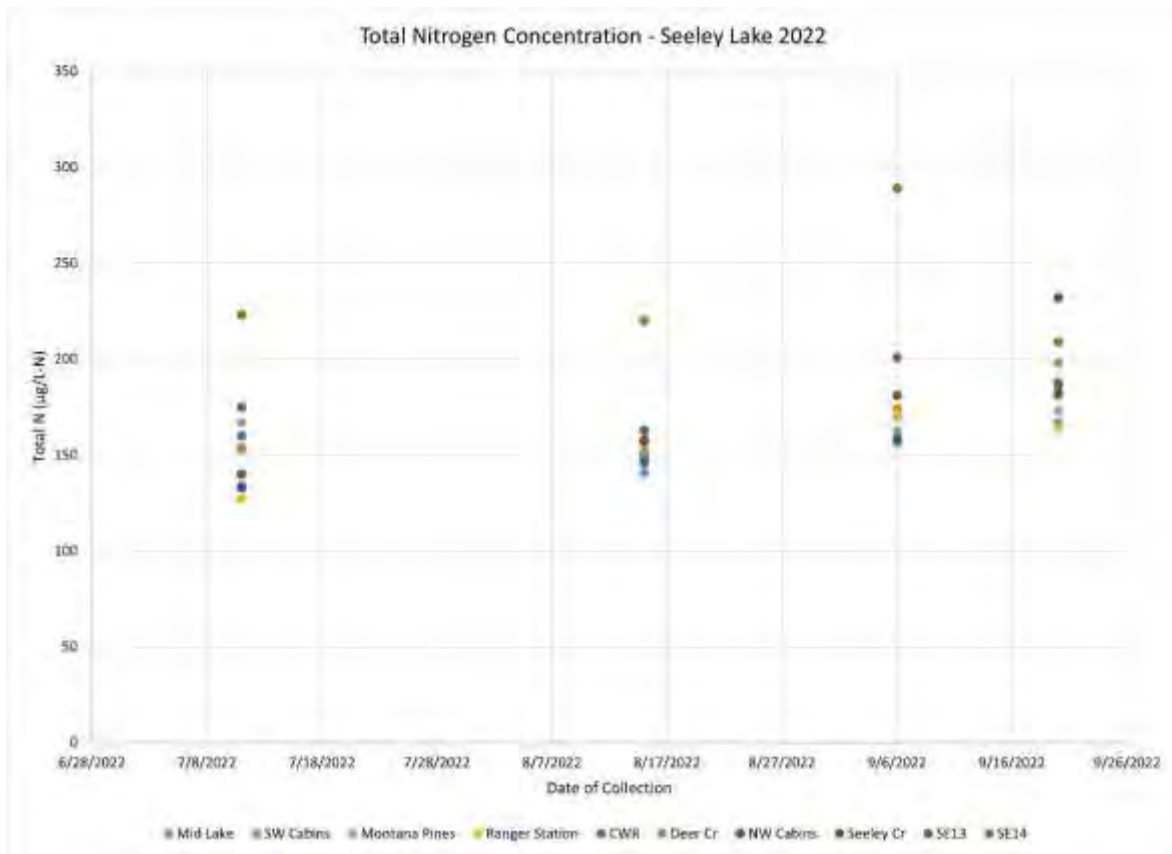
Figure 26. Total nitrogen levels across 7 surface sample locations and 1 deep sample (Mid Lake) for Seeley Lake in 2022.

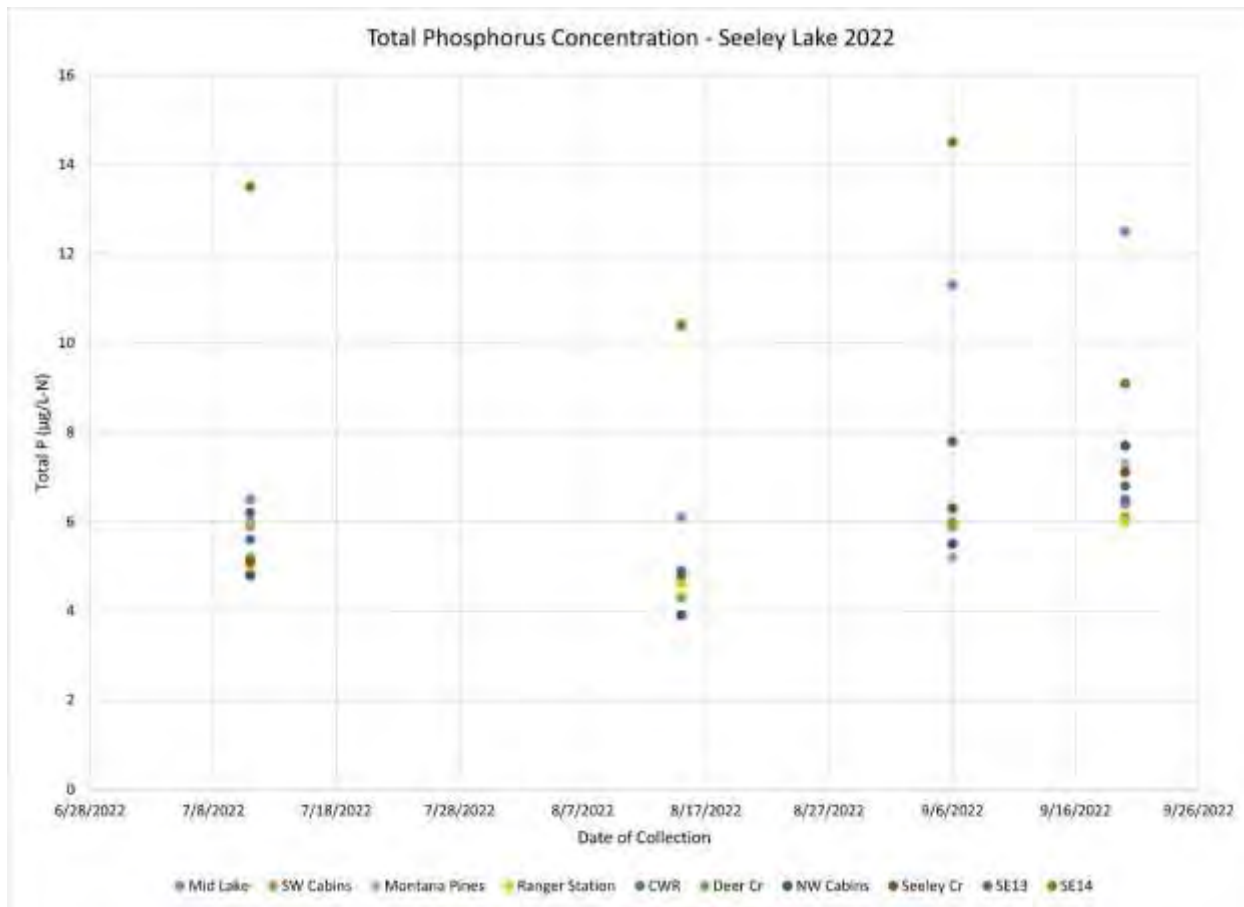
Figure 27. Total phosphorus levels for 7 surface sampling locations and 1 deep lake sample (Mid Lake) for Seeley Lake in 2022.

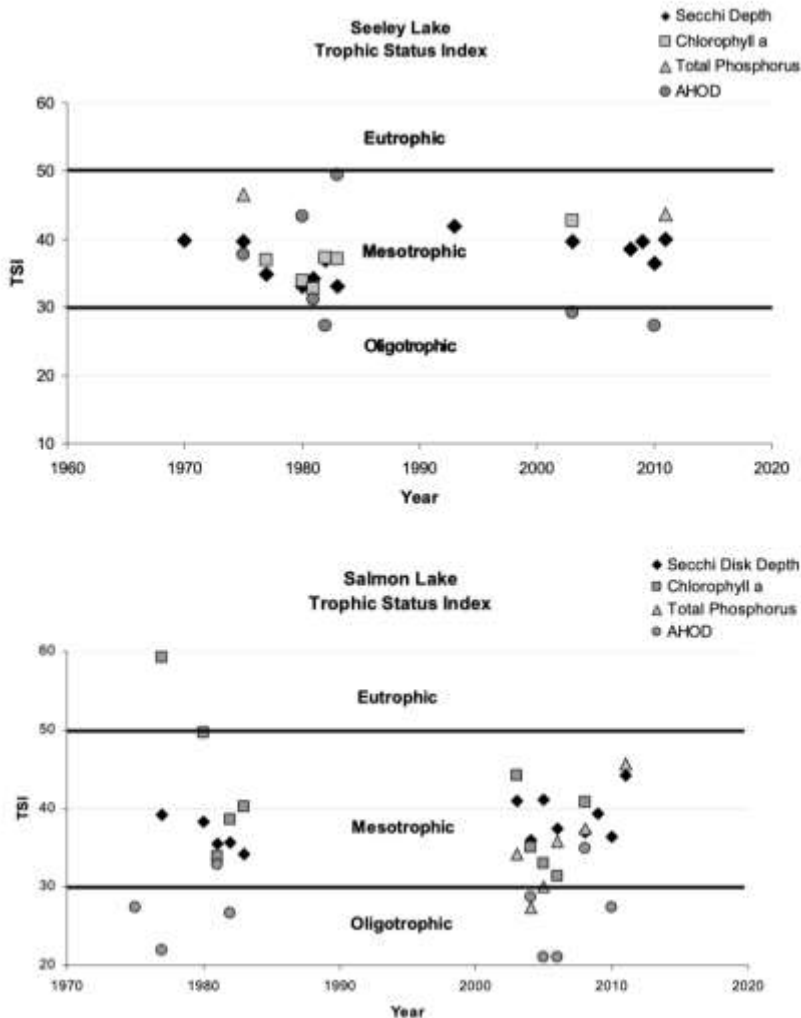
Figure 28: Trophic State Index values for Seeley Lake (top) and Salmon Lake (bottom), based on summer chlorophyll a, Secchi depth, AHOD, and spring turnover total phosphorus data from 1970's to 2011.

Prior to the formation of CRC, various local researchers collected data on the status of the major lakes in the Valley. Because methods and timing of measuring lake conditions varied over the years, a subset of most comparable data were used to compute TSI values (Figure 28) and AHOD values. And only these values are used to evaluate trends over time.

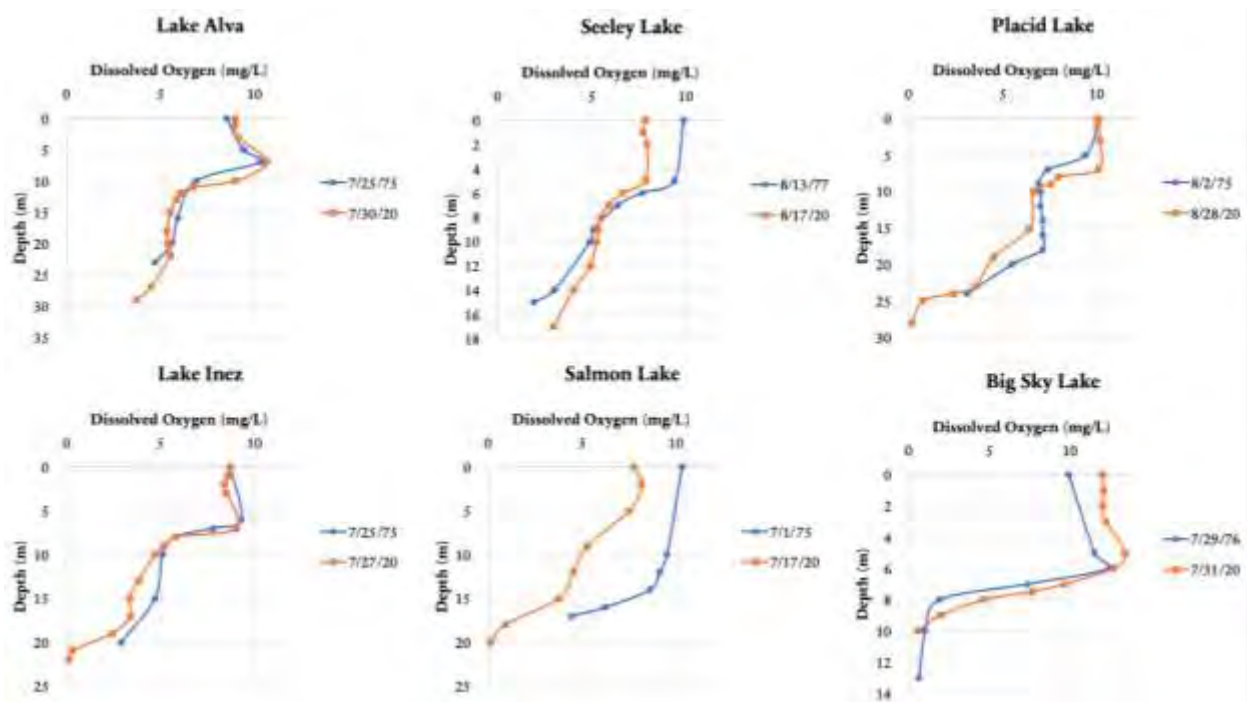
Dissolved Oxygen Levels: 1970s vs 2020

Figure 29: Dissolved oxygen (mg/L) vs depth (m) in 2020 and the 1970s for 6 lakes in the Clearwater Valley: Lake Alva, Seeley Lake, Placid Lake, Lake Inez, Salmon Lake, and Big Sky Lake.

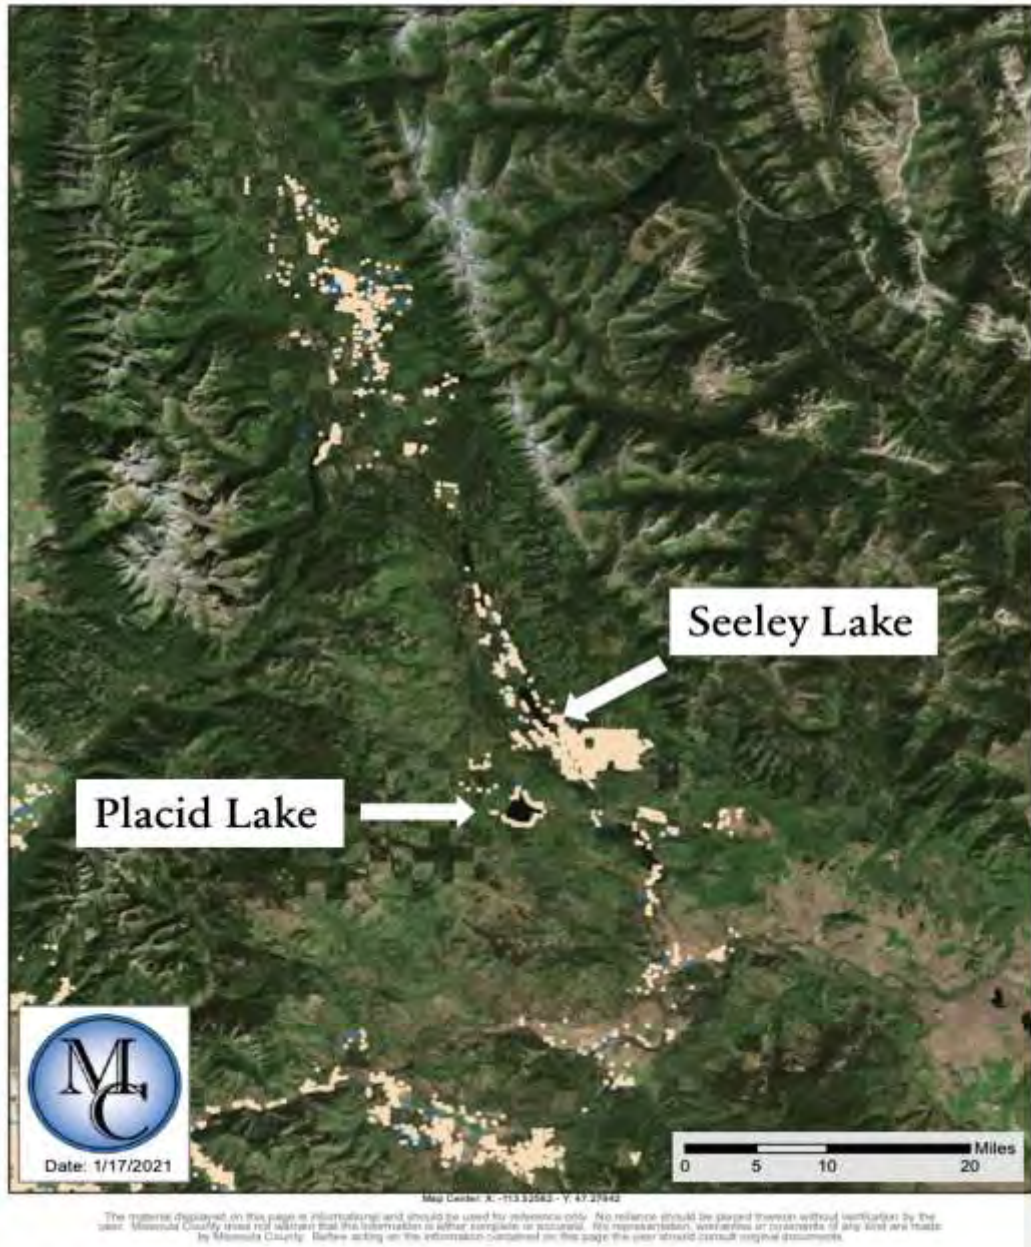
Figure 33: Location of septic systems in Missoula county. Note the high density directly adjacent to the major lakes. *Data Source: Missoula City-County Health Department*

Population growth has increased significantly in recent years (Figures 31 and 32). As Figures 31 and 32 show, most of this growth has occurred adjacent to the major lakes in the Valley (Figure 33). The community of Seeley Lake has no central wastewater collection or treatment system, and the public water-supply is drawn from Seeley Lake. As septic systems age, nutrients begin to break through the soil and reach the groundwater, and ultimately surface water. As such, the growth in septic systems around the lakes in the Clearwater Valley will undoubtedly increase nutrient loading into the lakes.

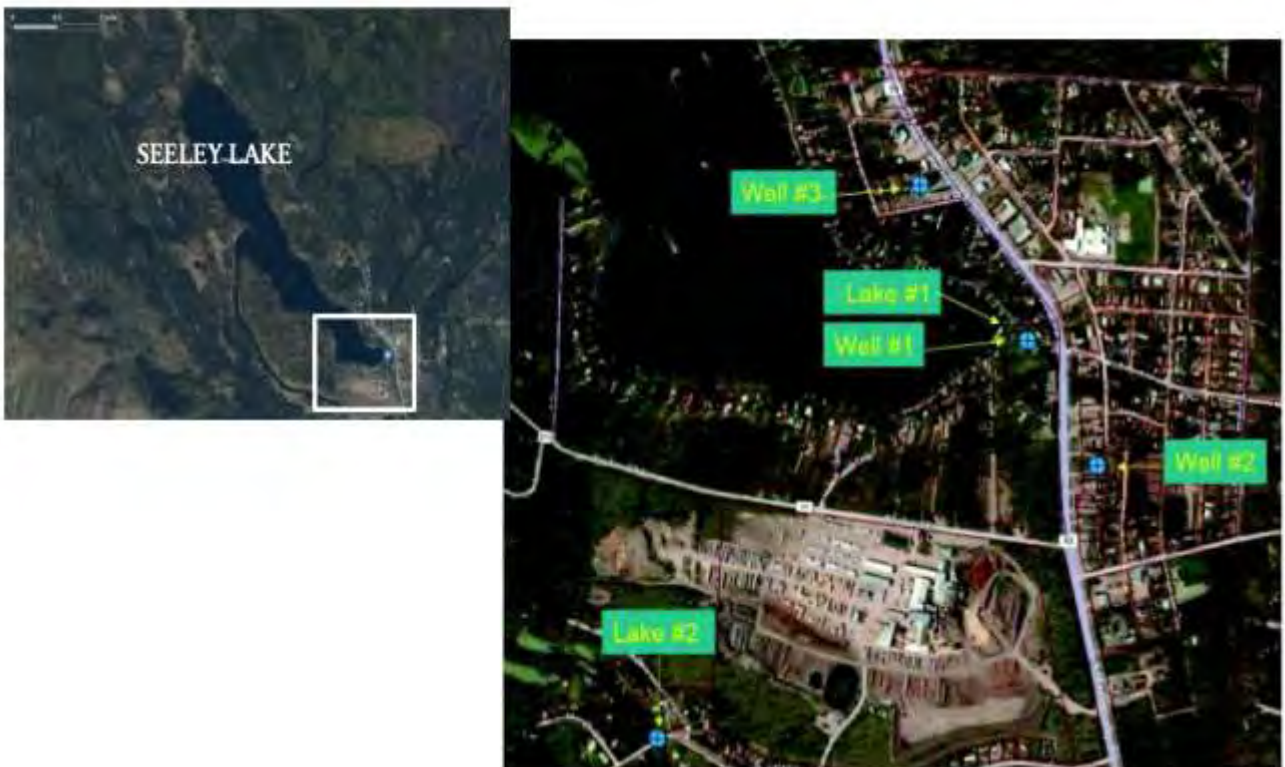
Figure 36 (a, b, c, d): (a-c) Nitrate/nitrite levels at three well locations in the vicinity of southern Seeley Lake, monitored by the Seeley Lake Water District over the last ~15 years. (d) Locations of wells and surface monitoring stations.

The Seeley Lake Water District has historically conducted groundwater (well) and surface water (lake) monitoring data from 2004 through present day in and around Seeley Lake for various parameters, including water temperature, pH, nitrate/nitrite, chloride, total coliform, and E. coli. The well and surface water sample locations are shown in Figure 36. Nitrate-nitrite concentrations for three wells and three surface water locations are shown in Figure 37. Well #1 near Lindy's exceeded the EPA's recommended maximum contaminant level of 10 mg/L on 7 occasions. Well #2 (Baptist Church) nearly reached the MCL of 10 mg/L. Concentrations in well #3 (Kurt's Polaris) do not appear to either increase or decrease over time and have stayed below the 10 mg/L threshold (Water Quality Association 2014). Natural concentrations in groundwater rarely exceed 0.6 mg/L with primary nitrate sources coming from human waste, animal waste, or fertilizer. The surface water samples have consistently exhibited near-zero concentration values.

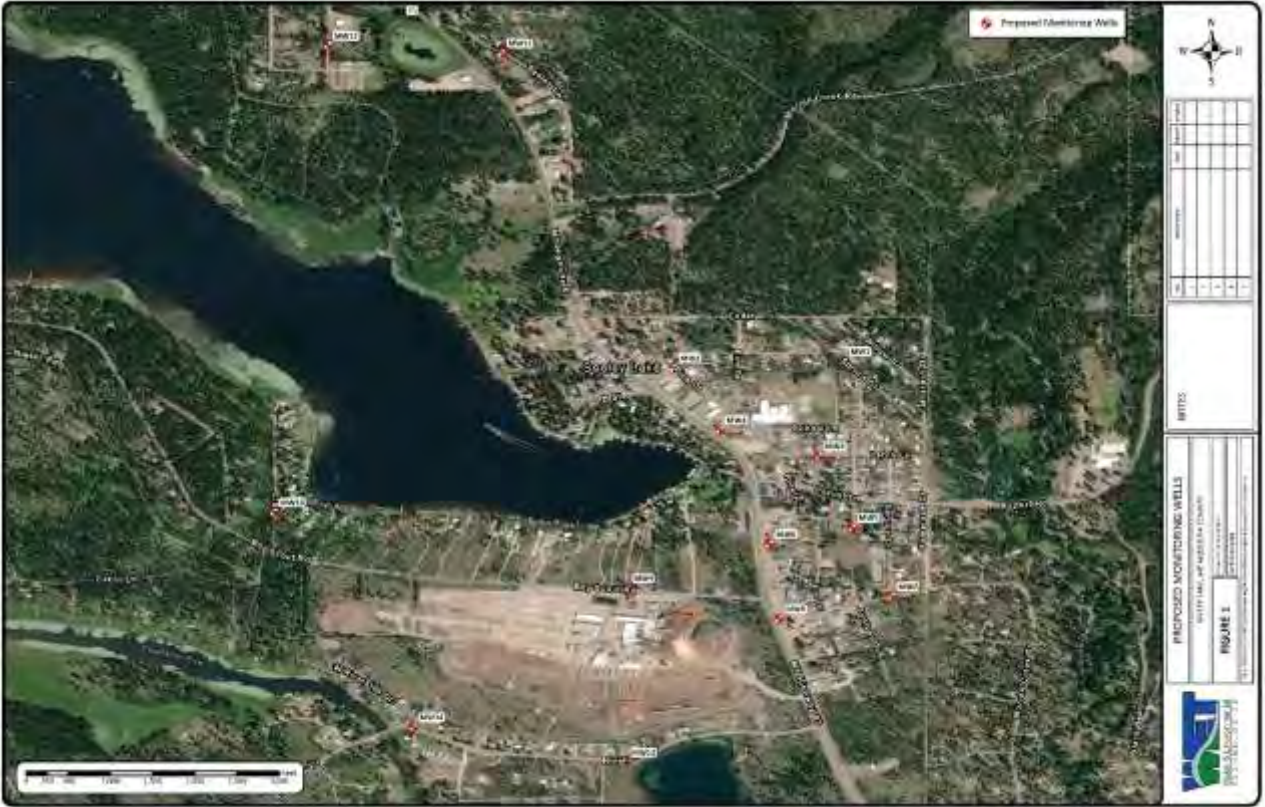
Figure 40. Location of new monitoring wells in Seeley Lake.

Most recently, a new set of monitoring wells have been installed in the Seeley Lake community (Figure 40). These wells are being sampled quarterly for chloride, nitrate, nitrite, total nitrogen, and total Kjeldahl nitrogen. A summary of the 2022-2023 samples (Figure 41) shows an exceedance of the maximum contaminant limit for nitrate at well #5. This exceedance occurred in June 2023. Other sampling of this well encountered dry conditions (no water). Remaining wells were below MCL standards but nitrate concentrations often approach the MCL standard and exceed expected background nitrate concentrations in groundwater. The highest nitrate concentrations were found at monitoring wells 2, 4, 5 and 13. Monitoring wells 2, 4, and 5 are located downgradient of the steepest (highest velocity) groundwater flow, based on the potentiometric surface (Figure 42) constructed by Norbeck and McDonald (1999), Nitrate and chloride concentrations are positively correlated, similar to the correlation shown in Figure 36 (Norbeck and McDonald, 1999) and exhibit a similar R-squared value. This relationship appears to add evidence that septic effluent is present in groundwater.

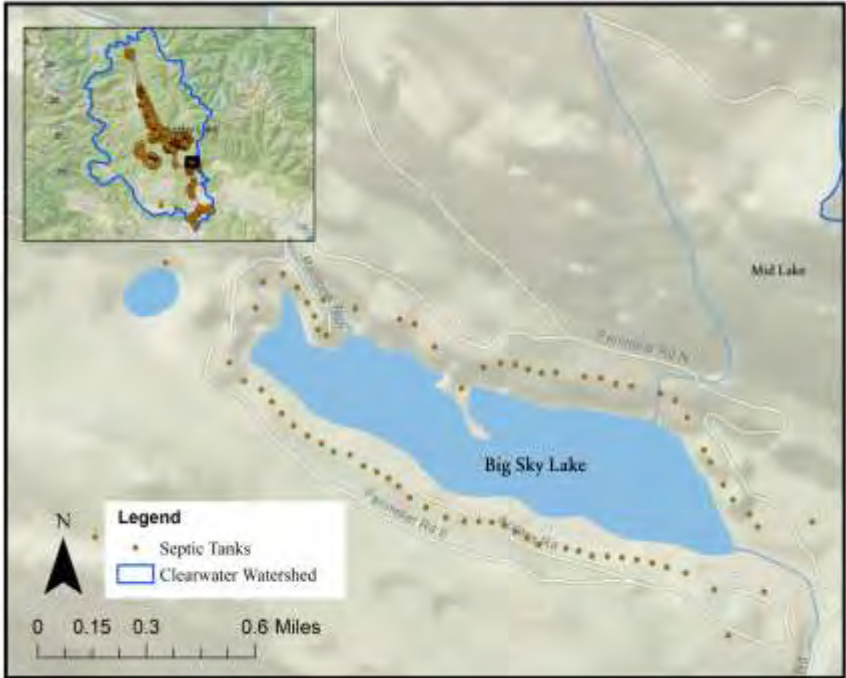
Figure 43: Septic tanks around Big Sky Lake.

Septic tank densities were mapped around the 5 most developed lakes in the Valley: Big Sky Lake, Placid Lake, Lake Inez, Seeley Lake, and Salmon Lake (figures 43-47).

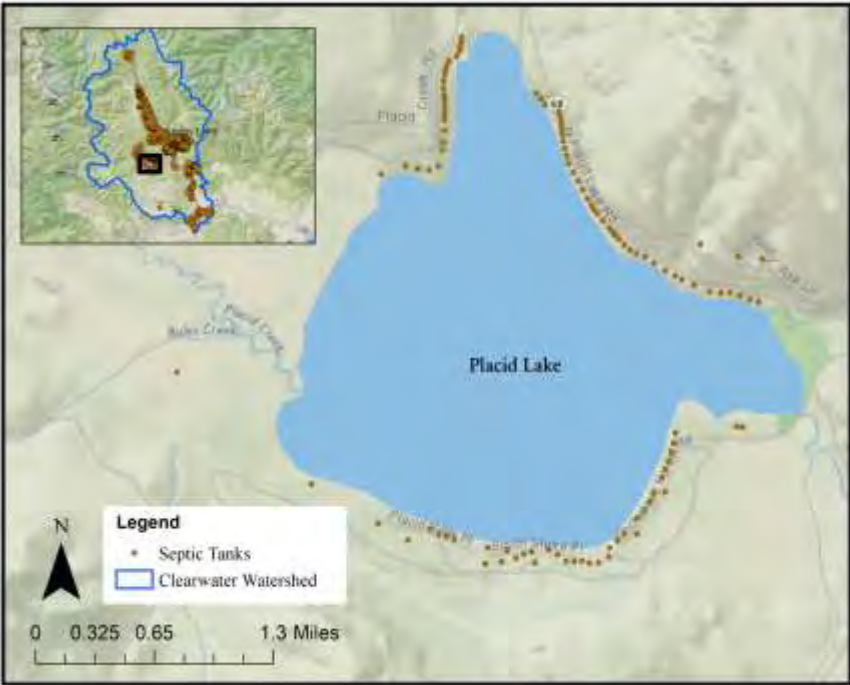
Figure 44: Septic tanks around Placid Lake.

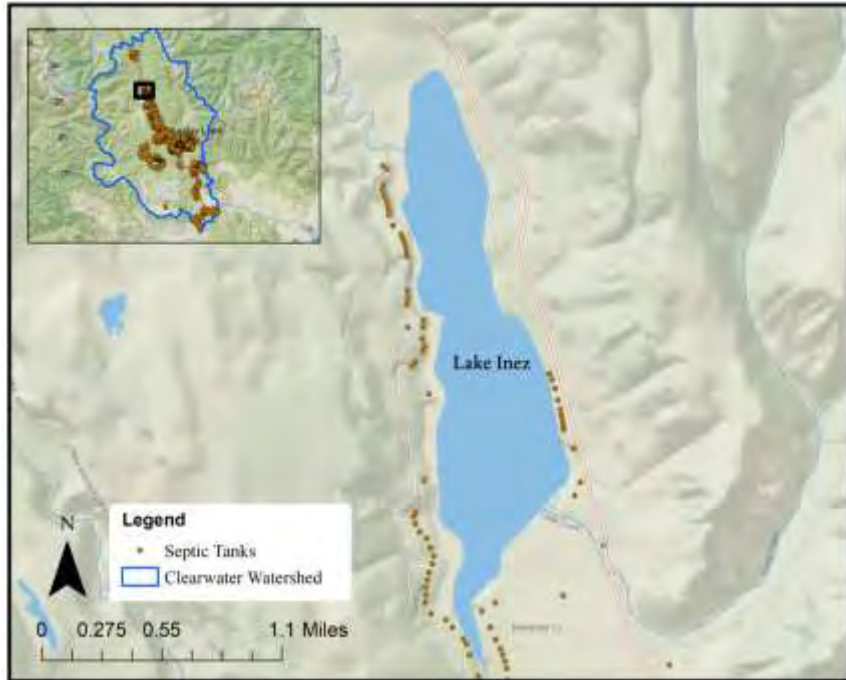
Figure 45: Septic tanks around Lake Inez.

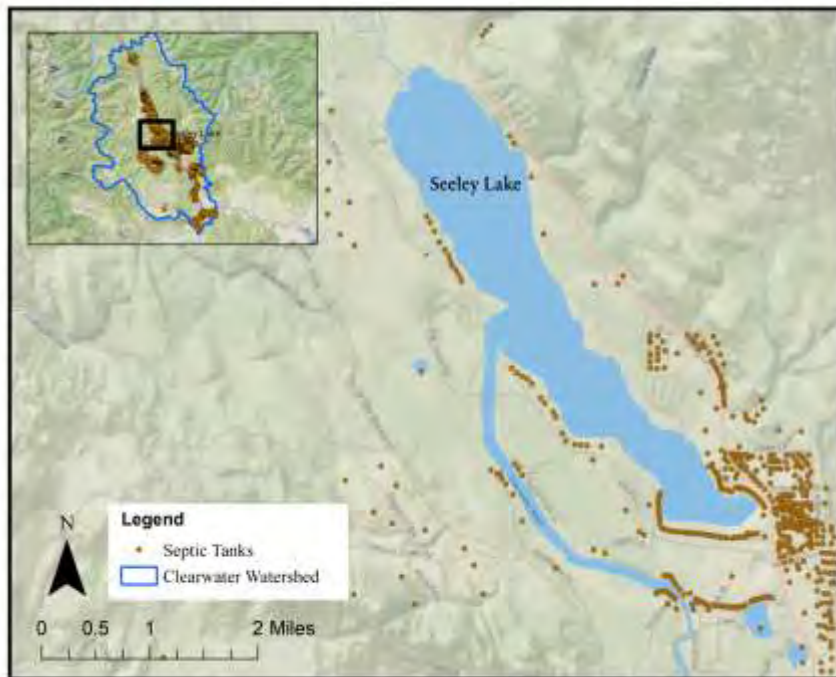
Figure 46: Septic tanks around Seeley Lake.

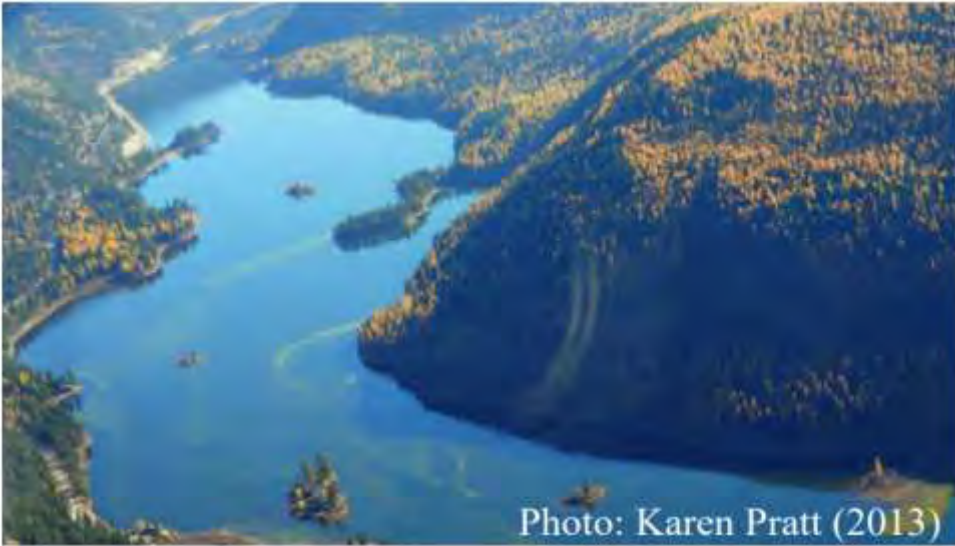
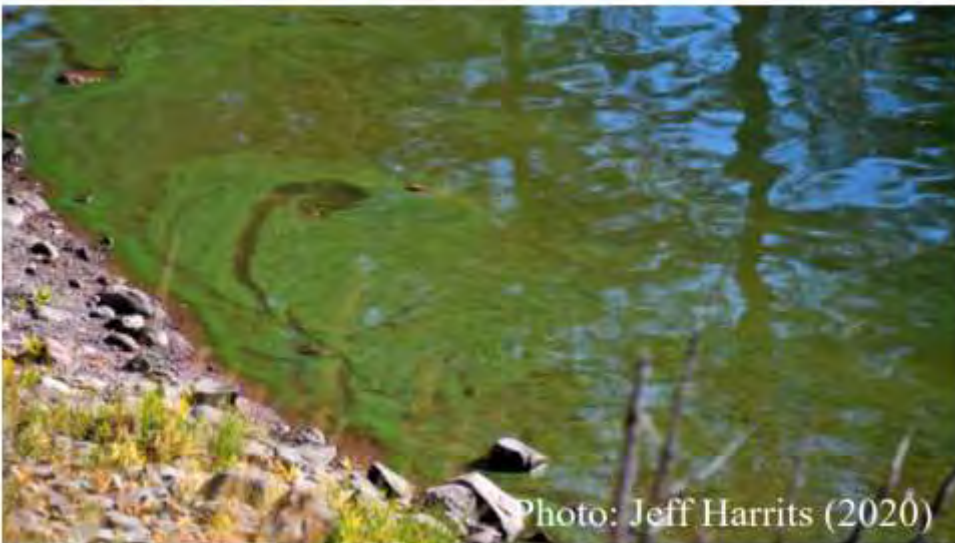
Figure 48: Top: an aerial view of the 2013 Salmon Lake algae bloom, photographed by Karen Pratt on a flight piloted by David Wallenburn. Bottom: the 2020 Salmon Lake algae bloom identified and photographed by Jeff Harrits south of the state park boat launch area.

Persistent and large-scale algae blooms have been observed on many of the lakes in the Valley in the past few decades (Figure 48). Although the presence of algae blooms has not been recorded with much consistency, the DEQ began publishing public reports of harmful algae blooms in 2017. According to their records, in 2018, blooms were reported on Placid Lake, in 2019 on Seeley Lake and in 2020 on Inez, Seeley, Placid, and Salmon Lakes (DEQ n.d.). The 2020 blooms on Placid and Salmon Lakes were identified by the Flathead Lake Biological Station as *Anabaena*, a taxonomic group of algae capable of producing a range of toxins which can be fatal if ingested. While most blue-green algae blooms do not produce toxins, all blooms should be considered potentially toxic to both animals and humans.

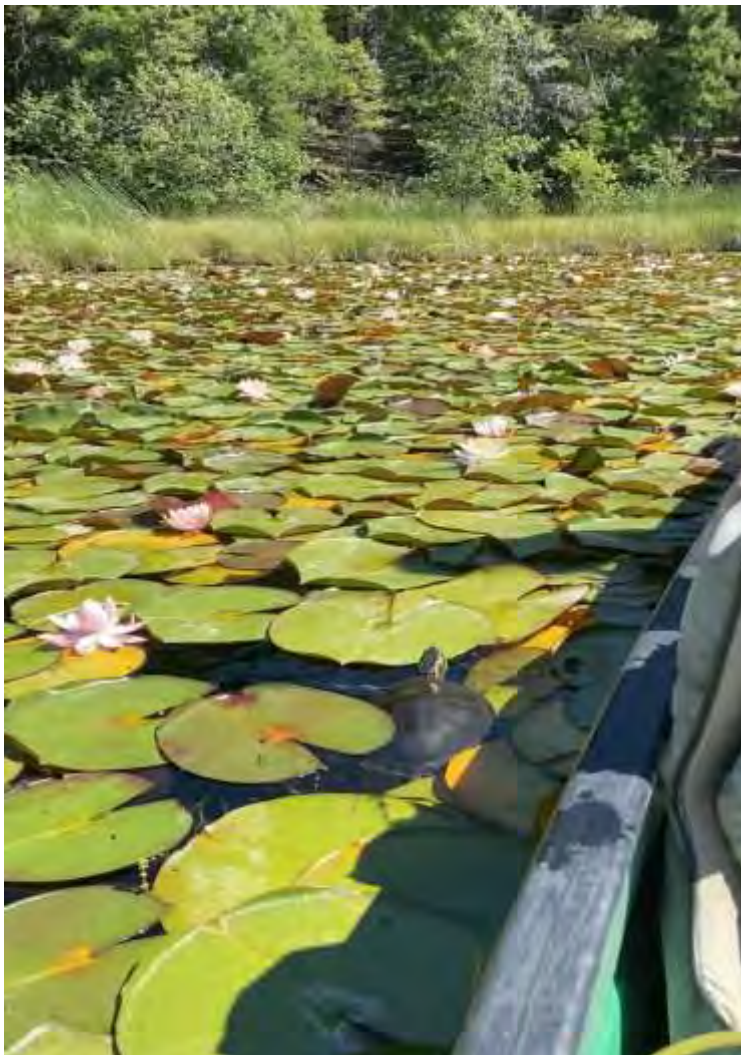
Figure 58: When left untreated, fragrant water-lilies can take over entire water bodies.

Montana has been infested by several aquatic invasive species, including faucet snails, curly-leaf pondweed, and fragrant water-lily. As of 2020, fragrant water-lily has heavily infested the Clearwater Valley (Figure 58). This invasive species is found throughout the watershed, including many of the major lakes (Inez, Salmon, Seeley, and Placid, among others). Like many other invasive plants, fragrant water-lily can spread rapidly and form dense mats that crowd out native plants and harm swimming beaches. This invasive plant also has rhizomes that make it extremely difficult to completely eradicate. If a rhizome root is broken up, the fragments will float to new areas and can create new patches of plants (Northey 2014). As more rhizomes break up, more fragrant water-lily plants are spread and established in an environment. Their rhizomes also allow them to tolerate drought and live in a range of habitats.

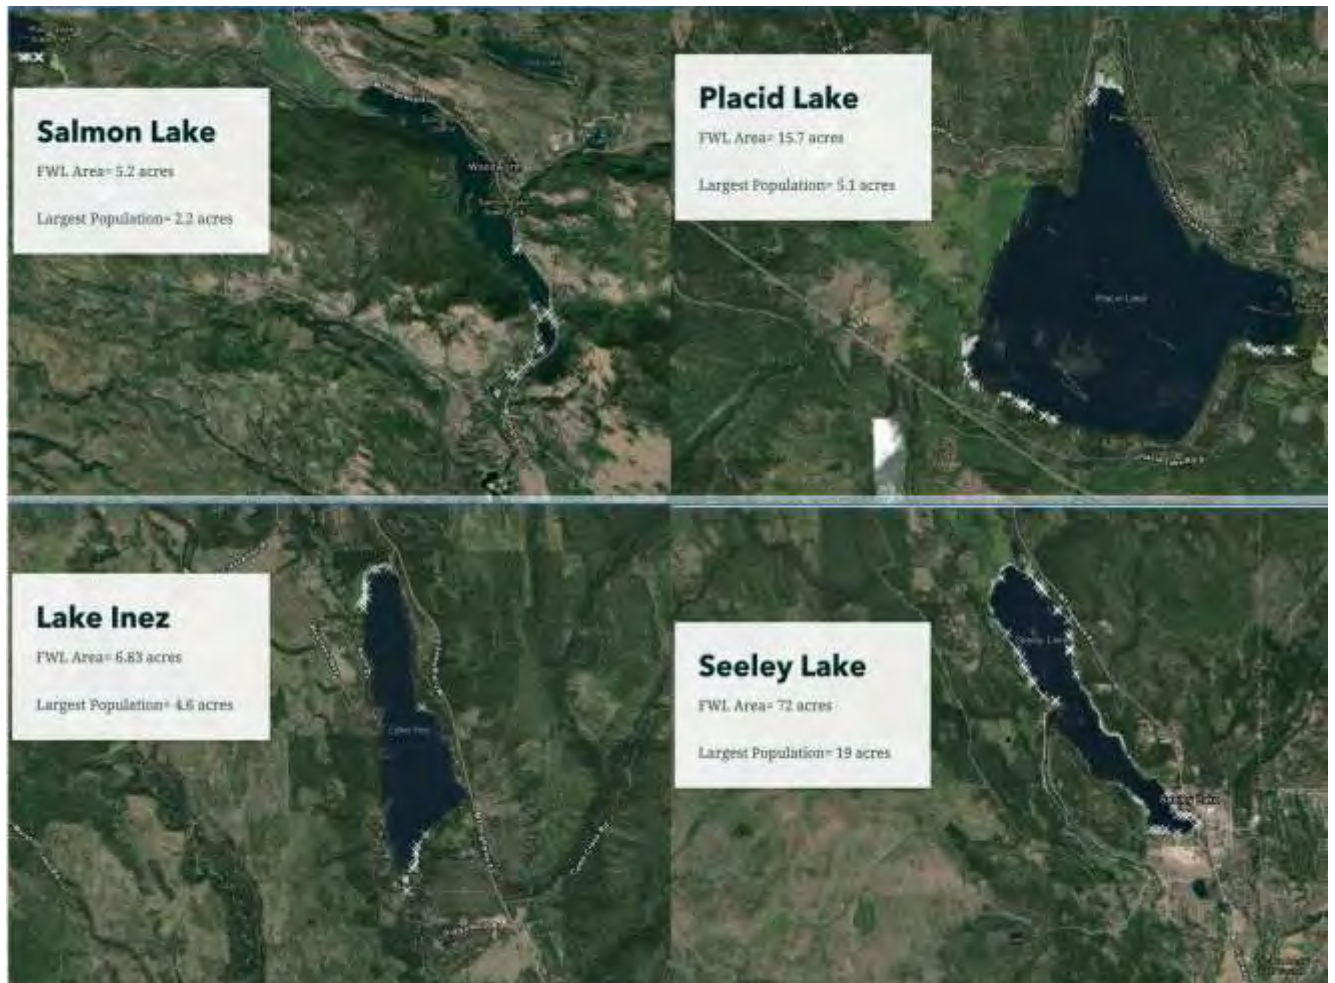
Figure 59: Fragrant water lily populations have established on four of the major lakes in the Valley, mapped above by the Missoula County Weed District. *Data source: Missoula County Weed District*

Fragrant water lilies were first introduced to Salmon Lake in 1937 and have since spread to many surrounding water bodies. In 2020, the Missoula County Weed District embarked on an effort to map the spread of this invasive species and found that significant populations of water-lilies have established on 8 of the 19 water bodies surveyed in the Clearwater and Swan drainages within Missoula County. Four of the major lakes in the Clearwater Valley were mapped in 2020, with Seeley Lake having the largest area of lilies at 72 acres, followed by Placid Lake (15.7 acres), Lake Inez (6.83 acres) and Salmon Lake (5.2 acres) (Figure 59) (Missoula County Weed District 2021).
