Investigation of Optical Brightening Agents (OBAs) in the Major Lakes of the Clearwater Watershed in Montana

Clearwater Resource Council

December 2022

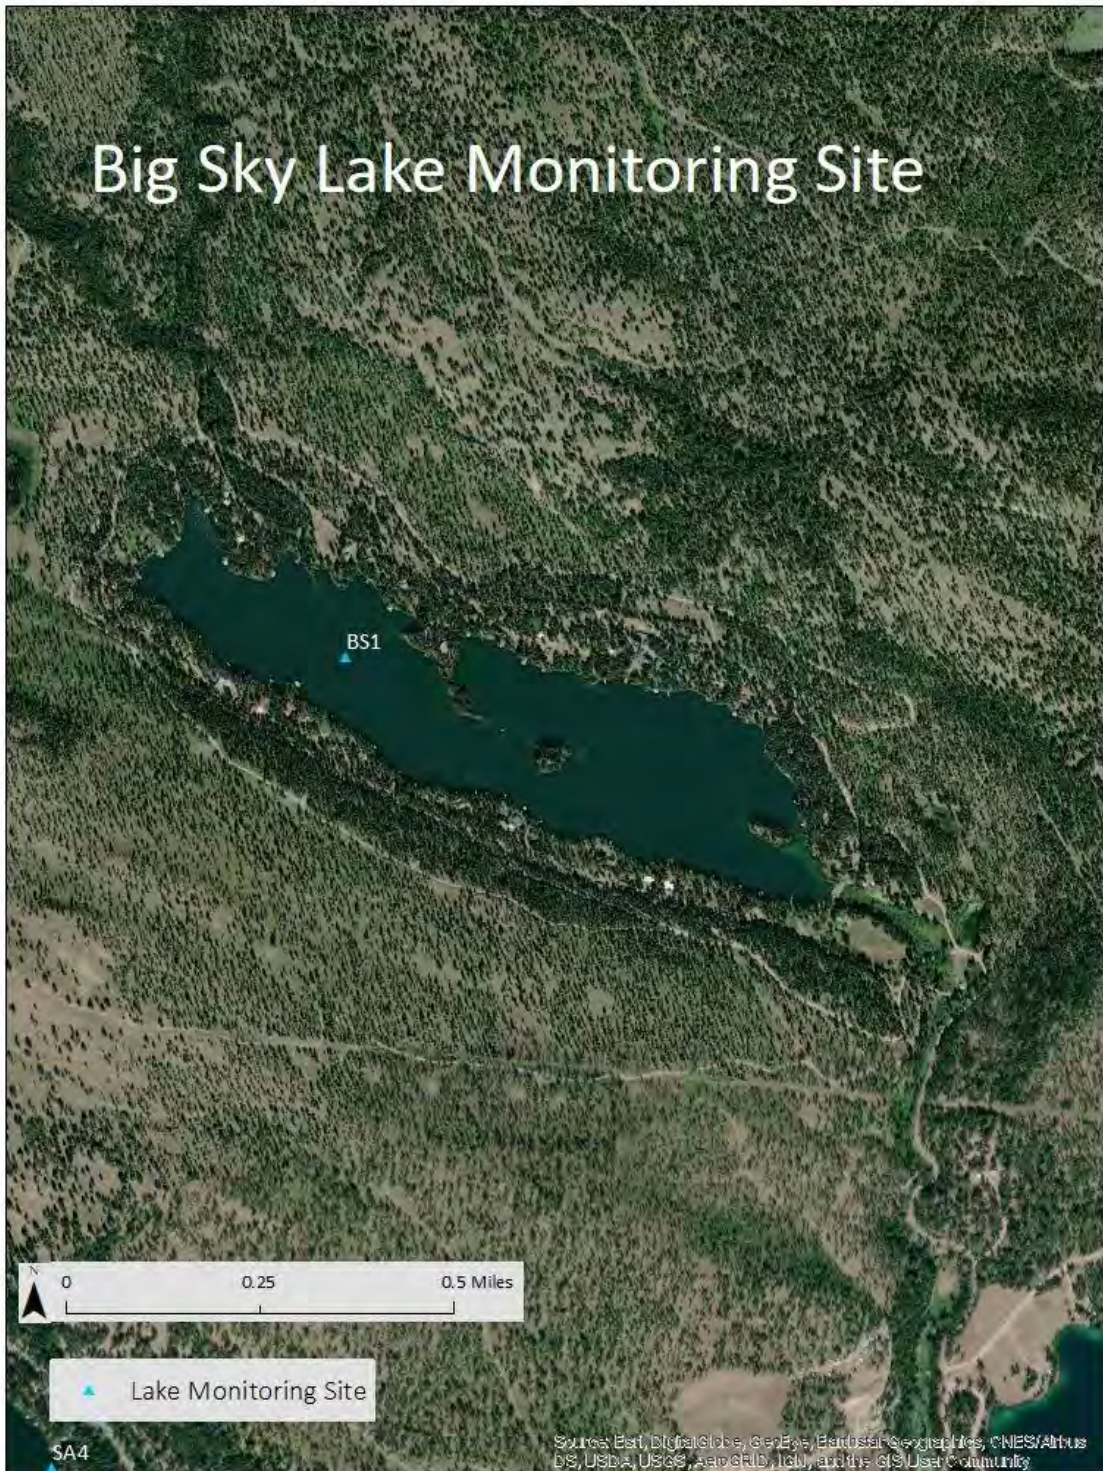
Lake Alva Monitoring Site

A varied amount of sample sites were chosen for each lake based on lake size and population density. Seeley Lake has ten sites, Placid Lake has four sites, Lake Alva has one site, Lake Inez has four sites, Salmon Lake has five sites, and Big Sky Lake has one site. Table 2 below details the ID and location of each site. Every lake has one site that corresponds to the deepest point in the lake. Most of the other sites are located near the lake shore. Maps depicting the location of all the sample sites can be found in Appendix B.

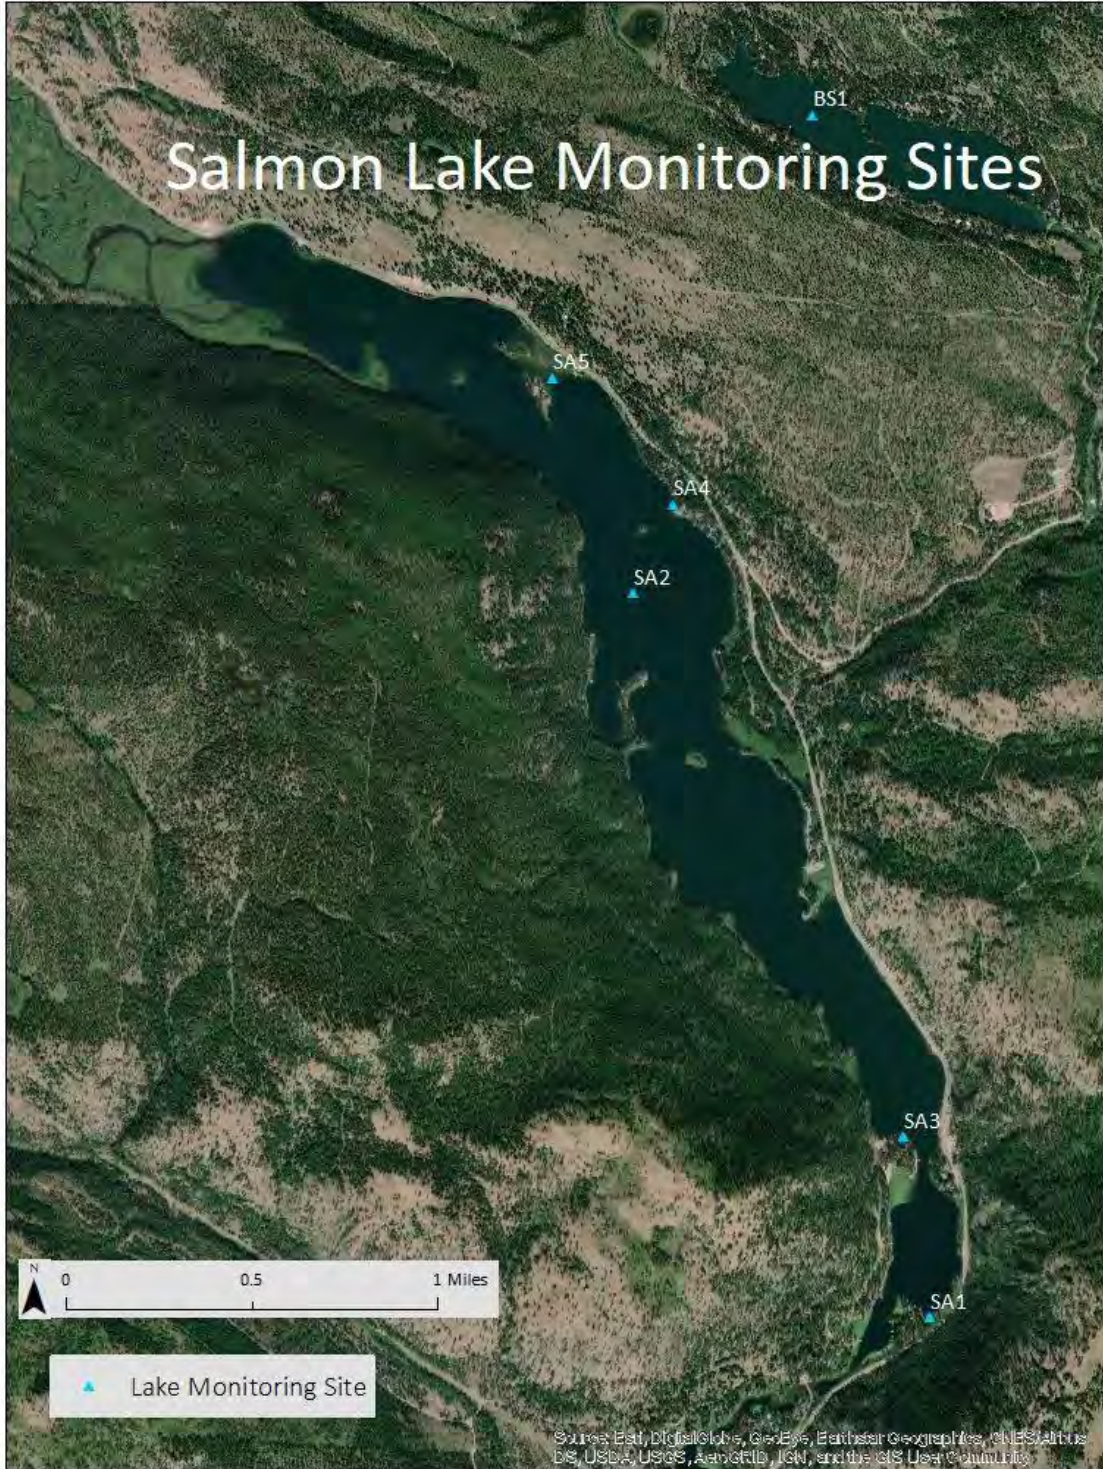
Seeley Lake Monitoring Sites
